Inspection Report

Property Address:
888 Home Inspection Way
Wantagh NY 11040

Date: 11/30/2010	Time: 09:30 AM	Report ID: N12-0510
Property: 888 Home Inspection Way Wantagh NY 11040	Customer: Ms. Michelle Diamond	Real Estate Professional: Jayme Lancellotti Prudential Douglas Eliman

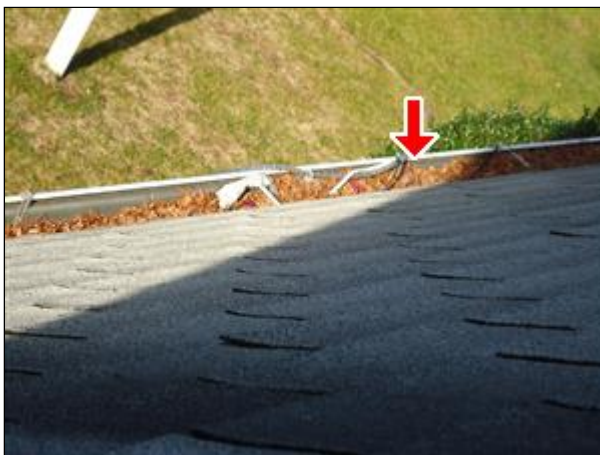
1.6 Picture 1

1.6 The gutters are full of debris in areas and needs to be cleaned. The debris in gutters can also conceal rust, deterioration or leaks that are not visible until cleaned, and I am unable to determine if such conditions exist.

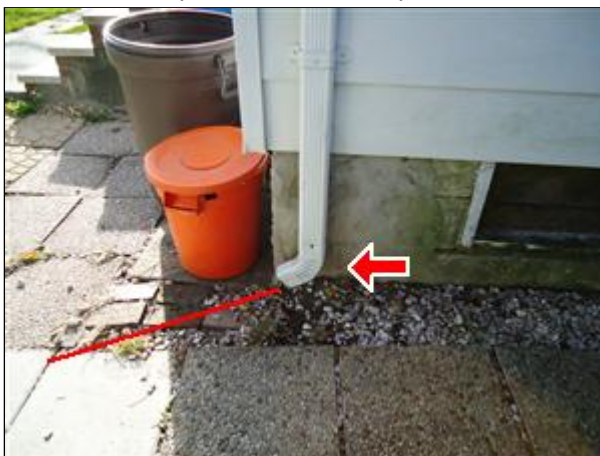
1.7 Picture 1

1.7 To minimize water ponding at the foundation and the potential for interior water penetration, downspout extensions or splash blocks should be utilized at the termination points of all downspouts/roof drains.

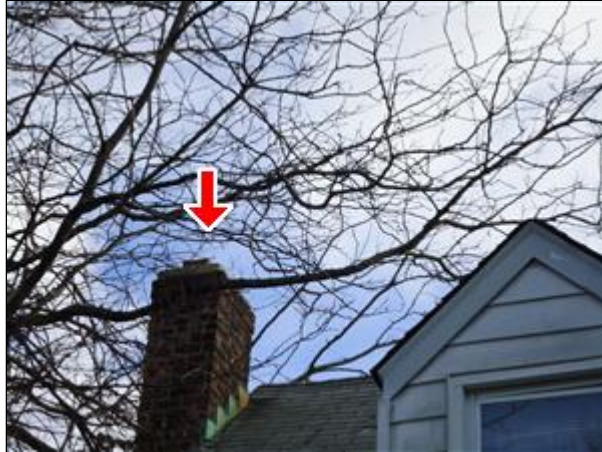
1.9 Picture 1

1.9 No chimney cap observed. Recommend installing to prevent the entrance of the elements, local wildlife, and to preserve the life of the chimney as well as minimize maintenance.

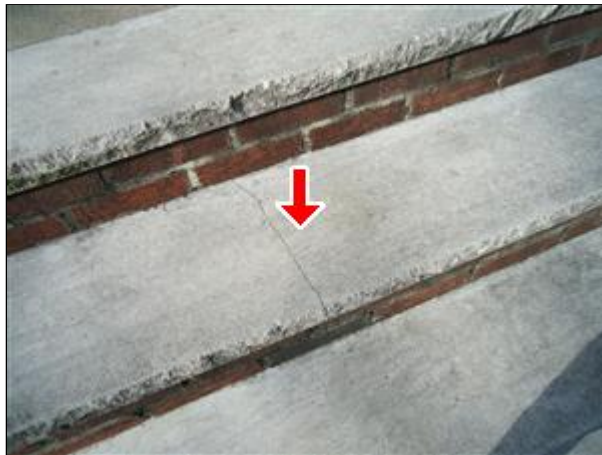
2.3 Picture 1

Stairs/stoops in rear of home shows some minor cracks,repair or replace as desire.

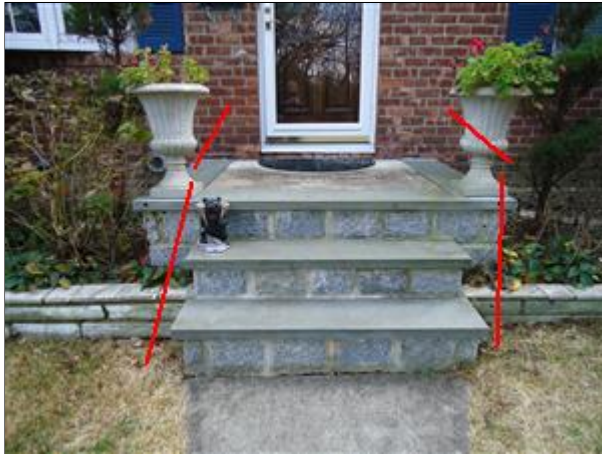
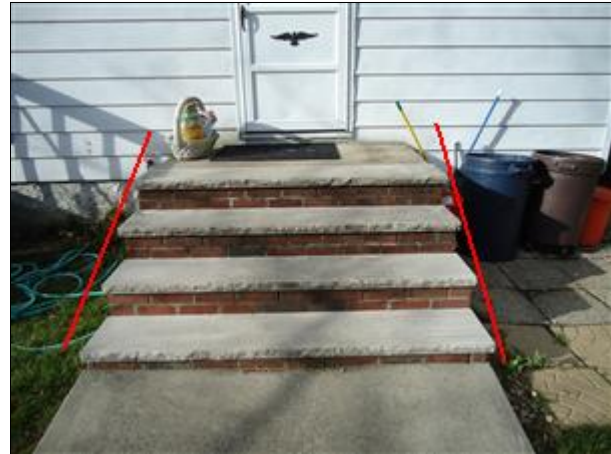
2.4 Picture 1

2.4 Handrails are required along the stairway. They must be graspable and securely fastened to the wall and/or support.

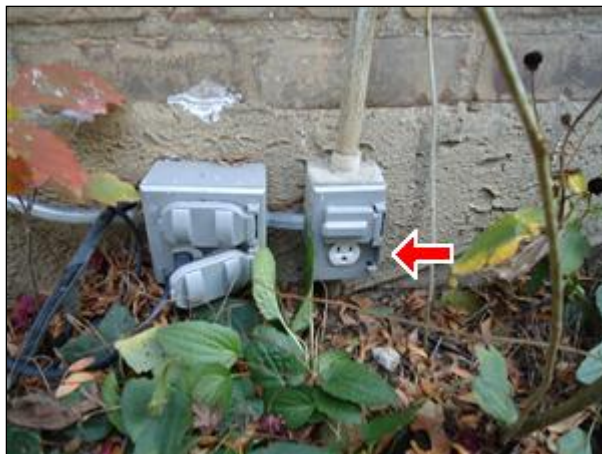
2.6 Picture 1

2.6 (1) Replace missing/broken weatherproof outlet cover on exterior outlet at front of home,and the outlet has no power at the time of inspection,investigate and repair by a licensed electrician as needed.(or find out from the seller if there is a switch to control the outlet)

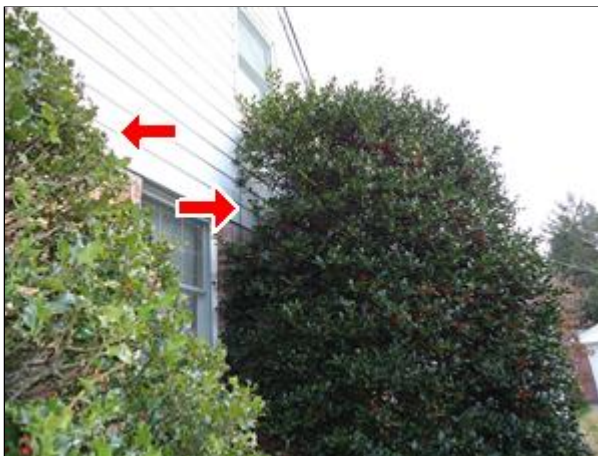
2.10 Picture 1

2.10 It is suggested that vegetations be trimmed away from house. A minimum clearance of 1 foot away from house is recommended.

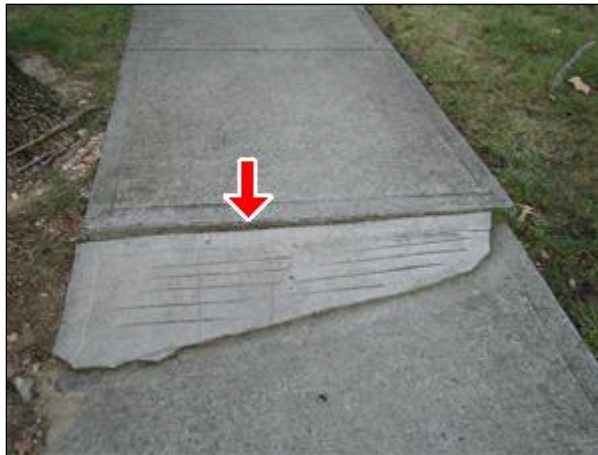
3.0 Picture 1

3.0 Cracking/heaving noted. Trip hazard, repair or replace as needed.

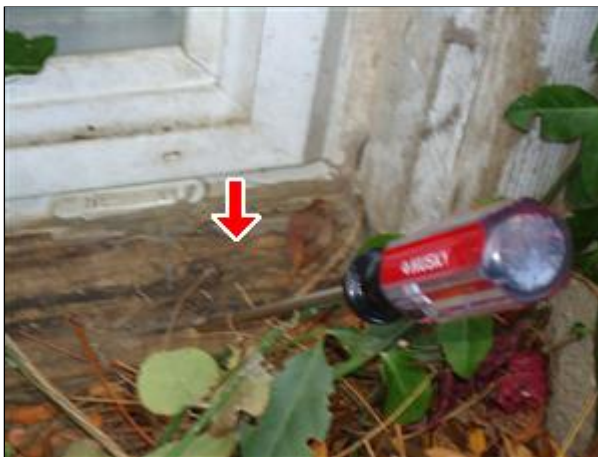
3.2 Picture 1

3.2 Rotted wood widow frame noted, repair place as needed.

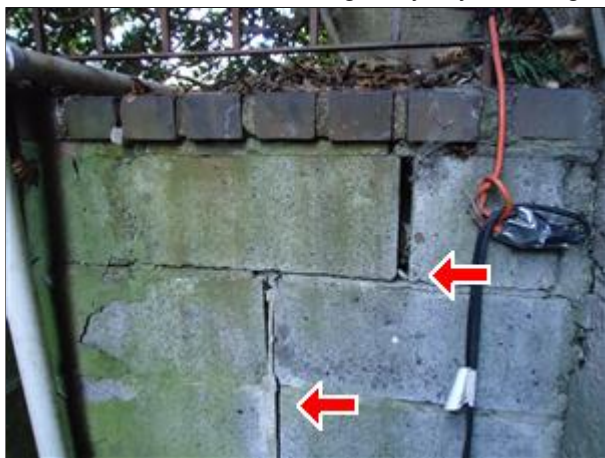
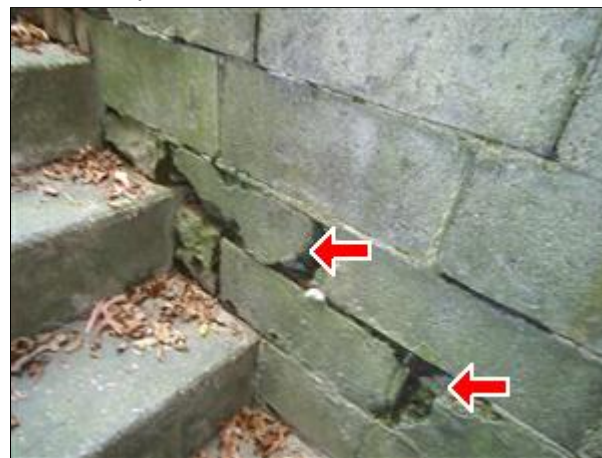
3.5 Picture 1

3.5 (1) Crack/deteriorated Sub-Grading entryway retaining wall noted, repair as needed.

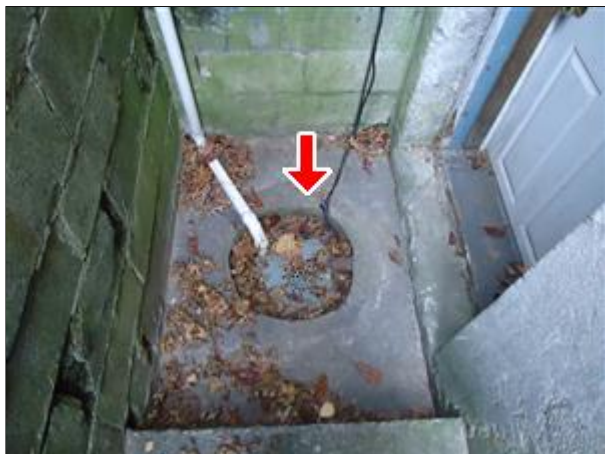
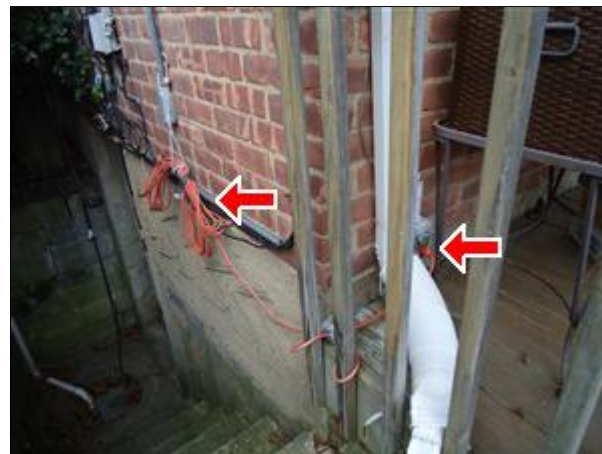
3.5 Picture 3

(2) Sump pump noted at the sub-grade entryway, not checked due to low water level in the pit. It is to recommend to find out from the seller if the pump is in good working condition.

Sump pump is improperly wired to outdoor outlet with extension cable, corrected by a licensed electrician as needed.

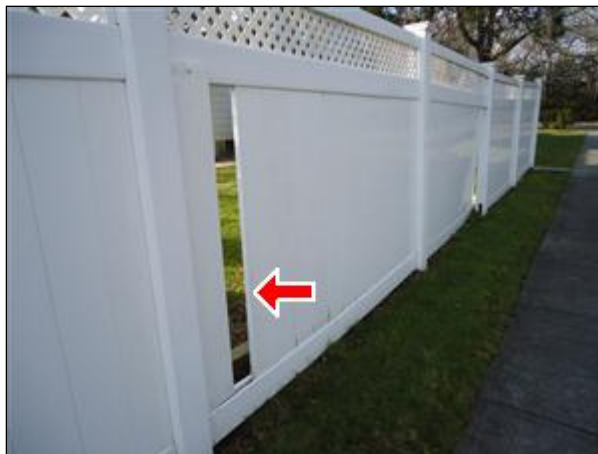
3.7 Picture 1

3.7 Damaged fencing observed. Have repaired.

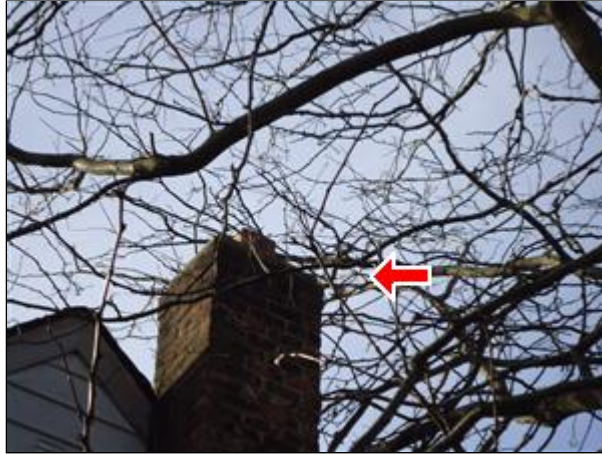
3.8 Picture 1

3.8 There is a tree growing too close to the left of the house, recommend remove or trimmed away from home.

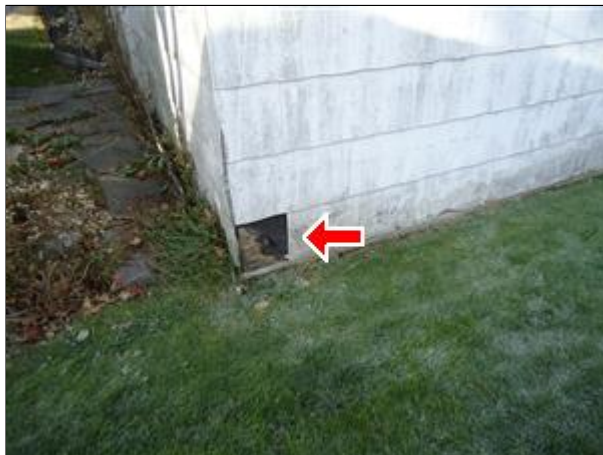
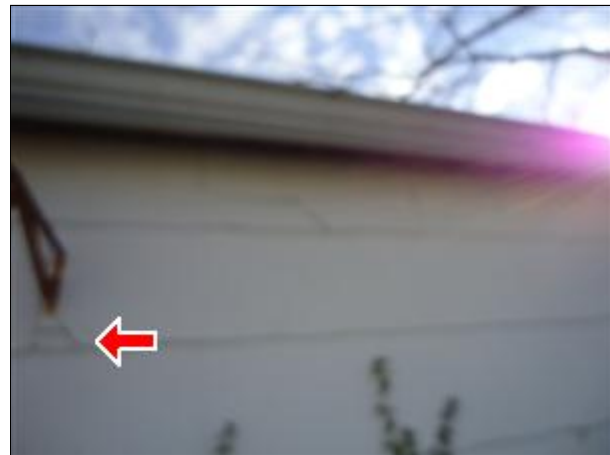
4.1 Picture 1

4.1 Asbestos cement siding at garage,racks and damaged sidings noted at many places.repair and replace as needed.

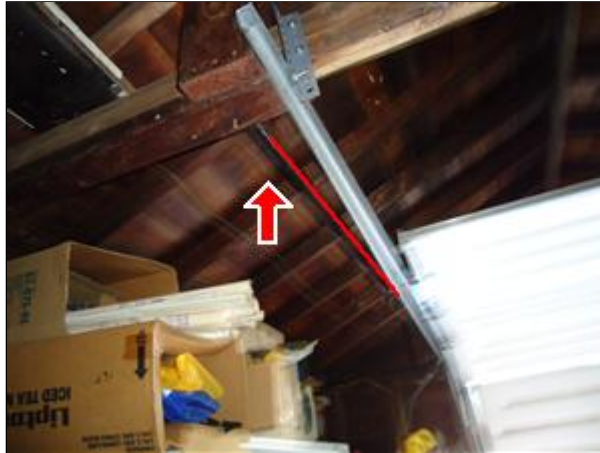
4.6 Picture 1

4.6 (1) No handle at door, recommend adding one.

(2) Recommend installation of "snubber cables" inside springs for safety.

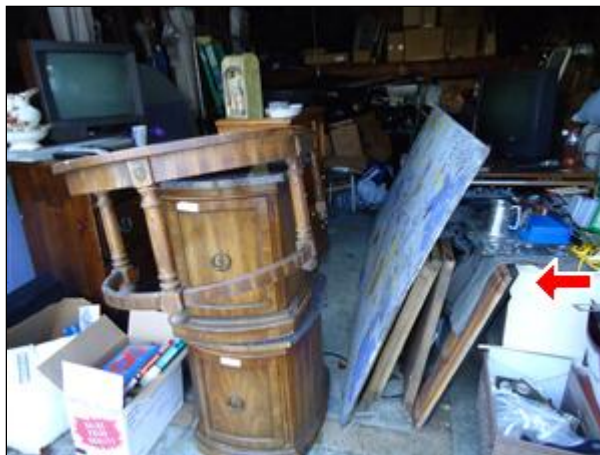
4.9 Picture 1

4.9 No evidence of wood destroying insects found in areas visible at time of inspection. Because it is impossible to see the framing in the entire structure due to the storages and the belongings inside the garage, we suggest that you consider a termite service contract from a licensed pest control company.

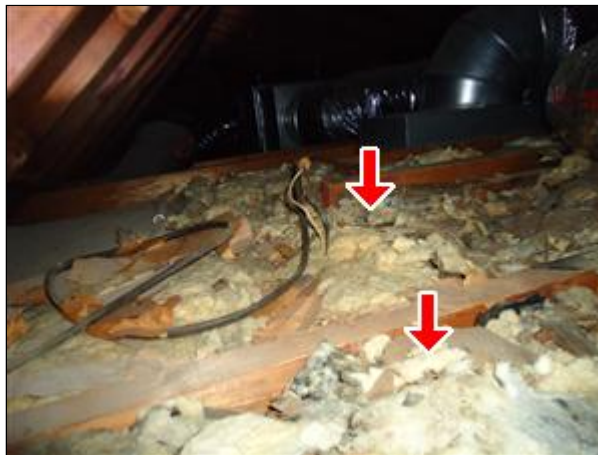
5.3 Picture 1

5.3 Insulation is inadequate according to today's standard, recommend adding adequate insulation for energy efficiency.

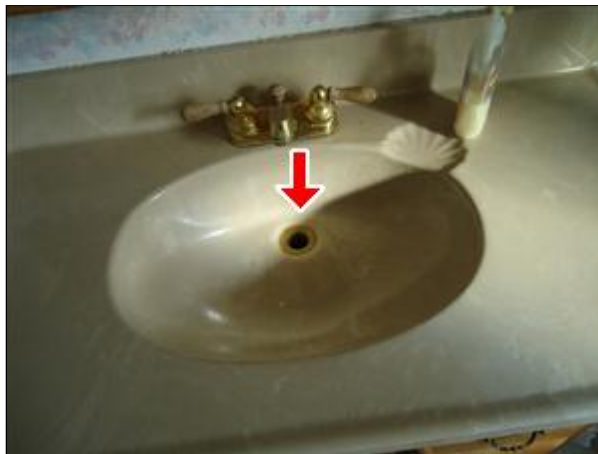
6.0.A Picture 1

6.0.A Stopper is missing. Correct is needed.

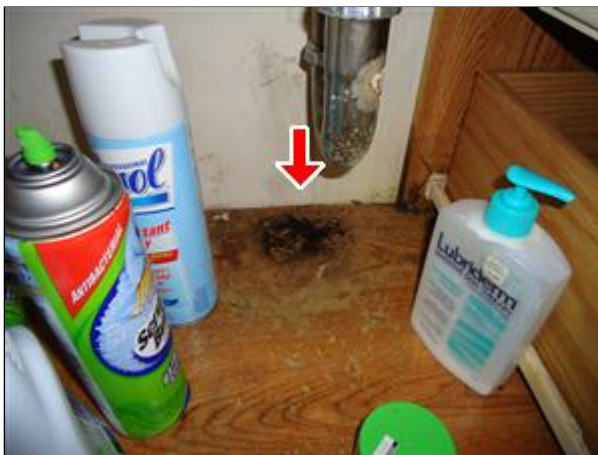
6.1.A Picture 1

Leak at hot /cold water piping. Repair as soon as possible to prevent further damage to the vanity or bathroom subfloor as needed.

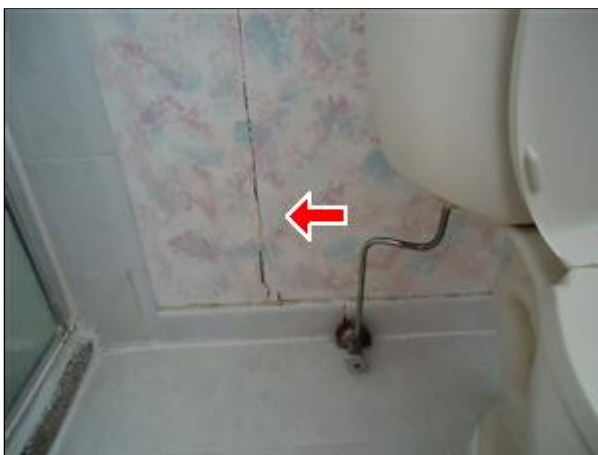
6.7.A Picture 1

6.7.A Cracks noted at wall, repair as needed.

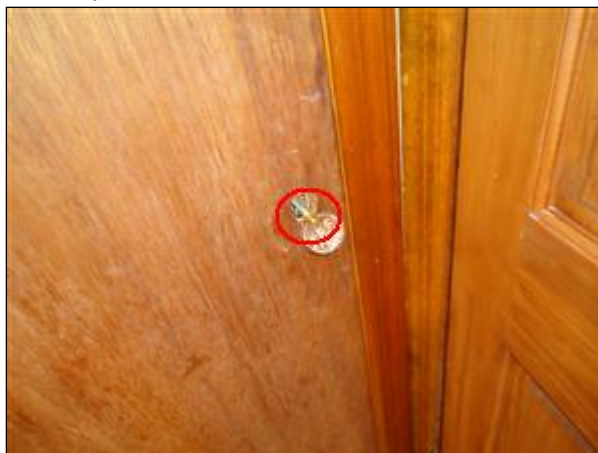
6.10.B Picture 1

6.10.B Damage noted at the closet door, repair as needed.

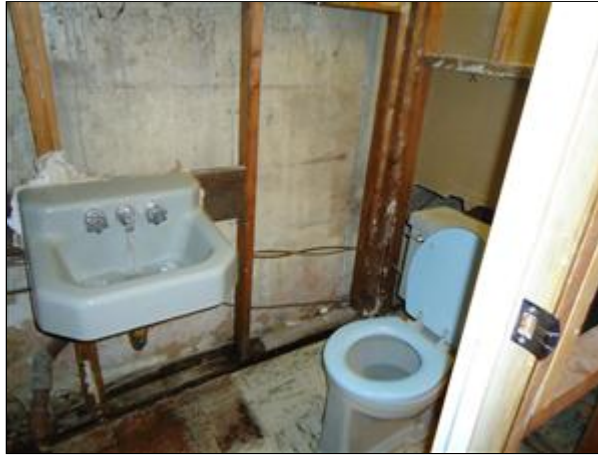
6.0.C Picture 1

6.0.C The basement bathroom is under renovation, work is not complete at the time of inspection, have an estimate from a licensed constructor for the cost of completion as recommended.

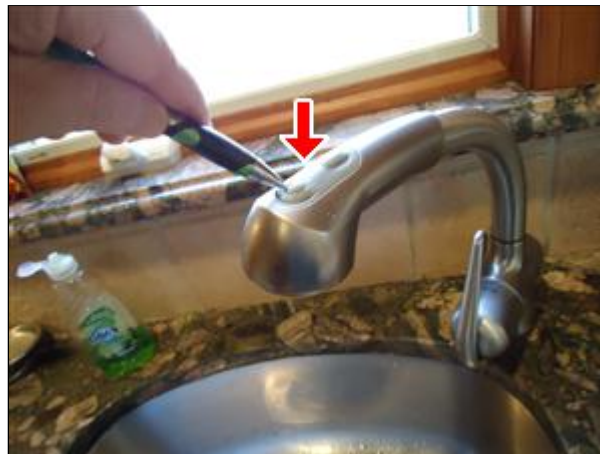
7.1 Picture 1

7.1 Faucet hand spray control is damaged,replace as needed,

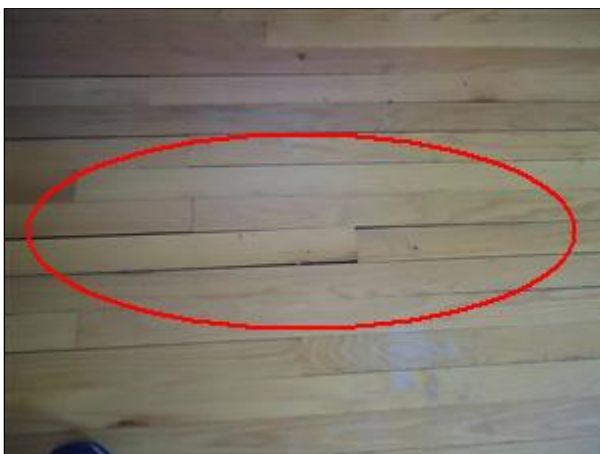
8.3 Picture 1

8.3 Wood flooring has some imperfect areas in the living room area,repair as desired.

Typical wear and imperfection noted at the carpet areas.

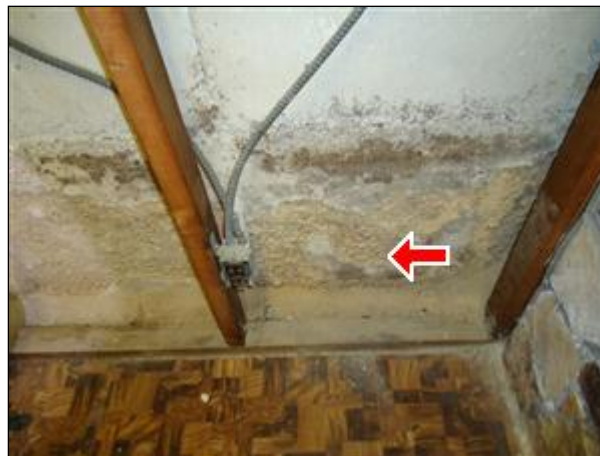
9.0 Picture 1

9.0 (1) Signs of deterioration and spalling noted at concrete foundation wall, contact foundation specialist for an evaluation / repair as needed.

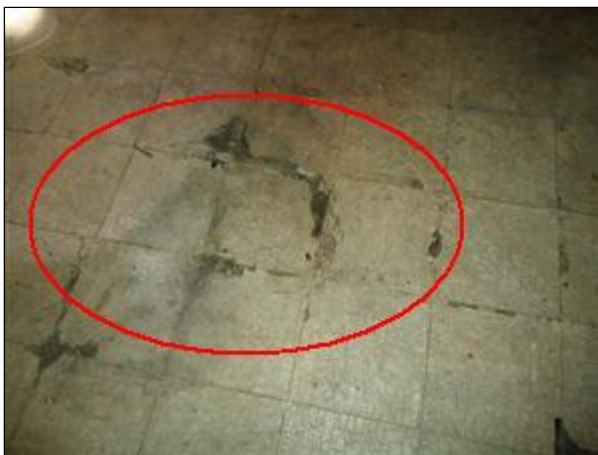
9.6 Picture 1

9.6 (1) Peeling/curling floor tiles indicates possible water penetration problems, evaluate by a basement water proof specialist as recommended.

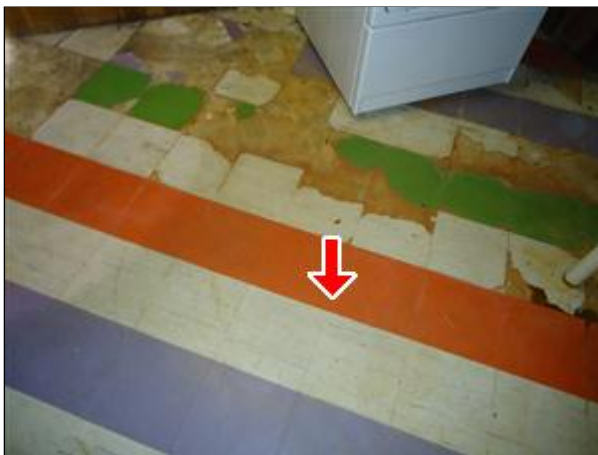
9.8 Picture 1

9.8 Possible asbestos floor tile. Suggesting testing and abatement as needed.

(If you want to install ceramic tile in that area, you can install ECB anti-fracture membrane over the asbestos floor tile for ceramic tile installation, the abatement is not needed.)

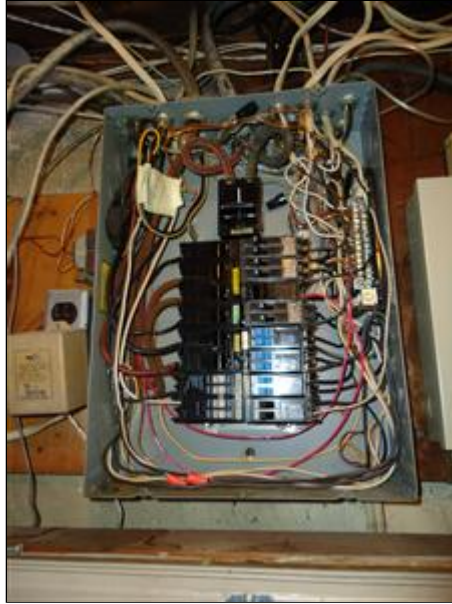
10.3 Picture 1

10.3 (1) Panel is full - no room for expansion. sub panel(s) or replaced with a bigger panel by a license electrician maybe required.

(2) panel maybe too small for the size of the house especially for today's living style. Evaluated by a licensed electrician is suggested.

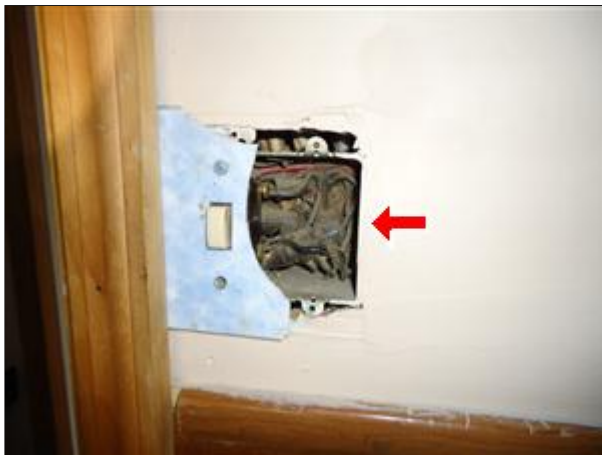
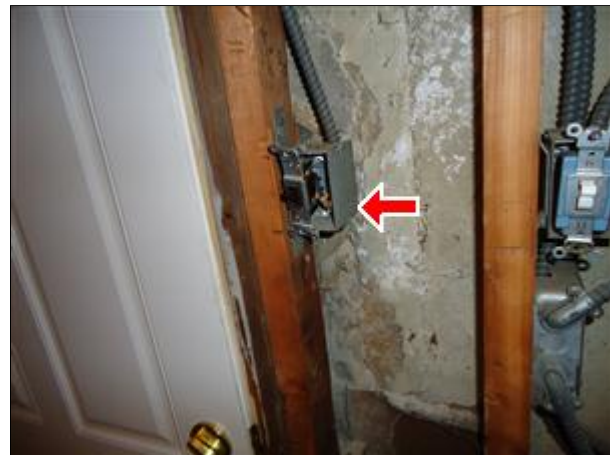
10.6 Picture 1

10.6 Exposed splices/missing/damaged switch or junction box covers found in many indoor area. Have a licensed electrician for a full evaluation and repair as needed.

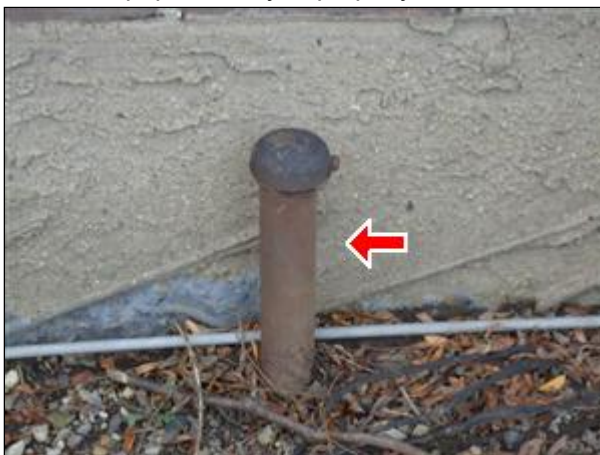
11.9 Picture 1

11.9 The buried tank is underground and was not evaluated. It's recommended to pump the oil out of the tank and install tank at another location. Remember to obtain papers that you properly abandoned this oil tank.

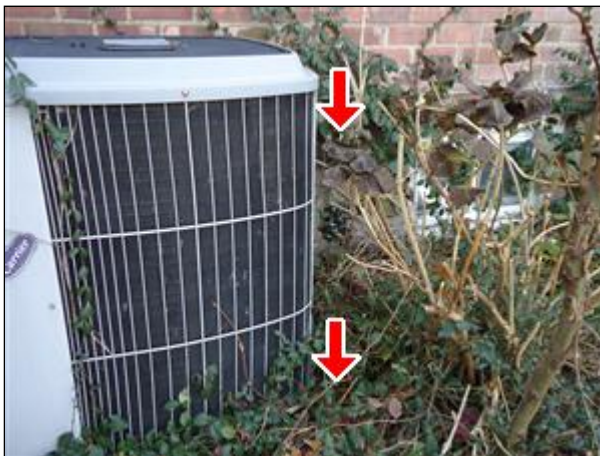
12.1 Picture 1

(2) It is suggest to trim the vegetation away from the outdoor unit to maintain the maximum air flow in the area for better efficiency.

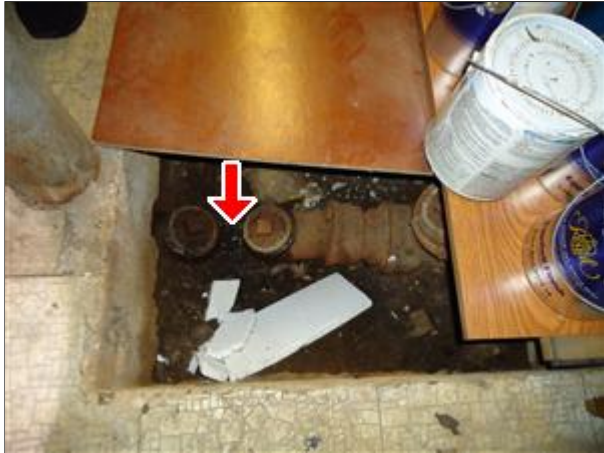
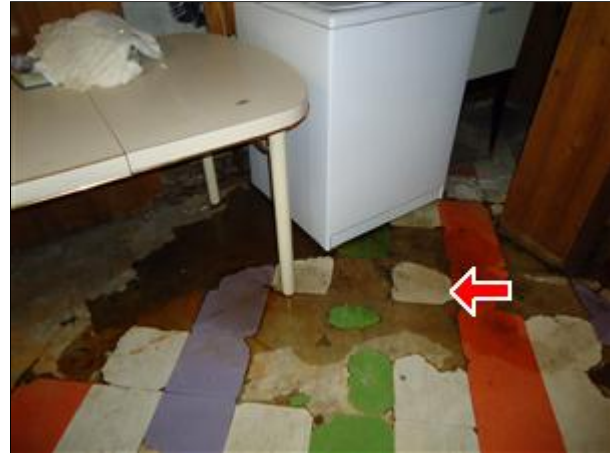
13.2 Picture 1

13.2 (1) Water backup noted in the basement house trap and laundry sink area at time of inspection, indicates waste line is clogged, clear by a licensed plumber as require. Also have the system checked by the plumber to find out possible other hidden problem as needed.

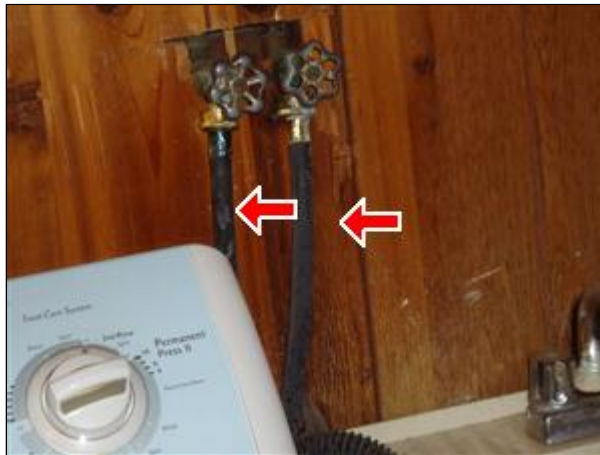
13.4 Picture 1

13.4 Suggest replace the rubber hoses with stainless steel hoses or install a washing machine automatic shut off valve to protect against water damage from the hoses burst.
